Kennedy Repairs One of the Largest Pumps In Michigan

PUMP DATA

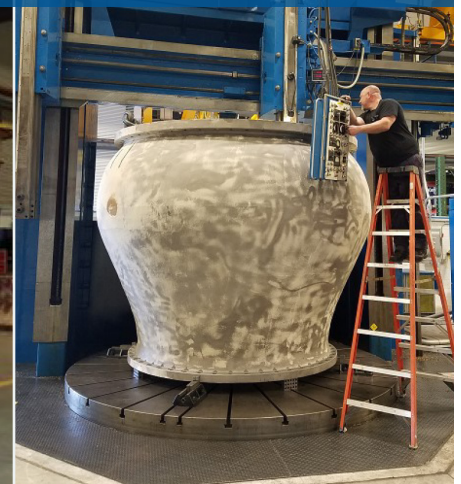
Indicating diffuser bowl to check concentricity of registers and machine case ring fit

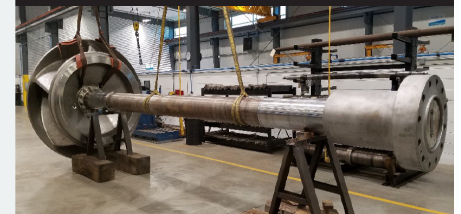
Rotor assembled and ready for balancing

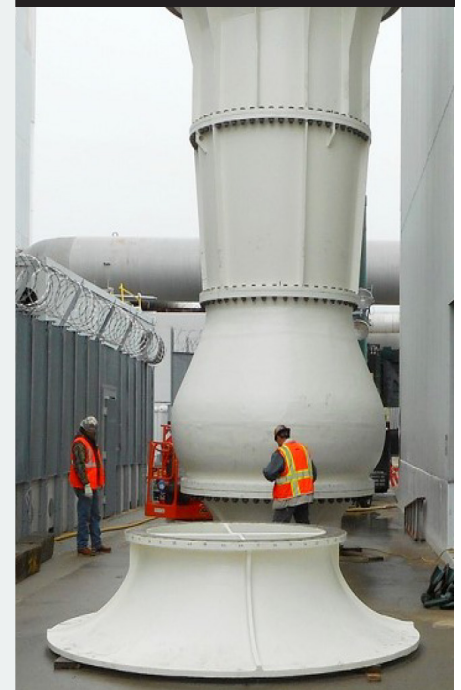
After being assembled outside pump is being lifted to install in pump basin
