Kennedy Industries Quickly Removes, Rebuilds, & Installs

The Removal of Mill Water Pump #7 by
Kennedy Industries Field Service Department

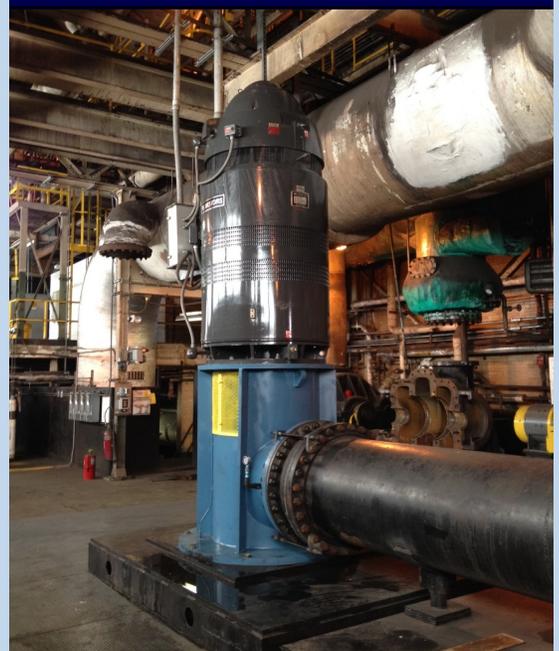
Newly Rebuilt Mill Water Pump #7 Installed

After careful consideration, it was determined the best course of action was to replace the existing 720RPM, 1250HP motor with a new 880RPM 1500HP motor. By doing this, the customer would be able to

maximize pump capacity and stay under the generators maximum output. They could also increase motor bearing life by specifically ordering a motor with 500% extra thrust capacity. Since the motor speed was being increased it necessitated the need to trim the massive impellers to maximize performance while not overtrading the new motor.

Kennedy Industries Field Service Department was hired to remove and reinstall the pump and motor. Upon removal, the pump was placed on a flat bed from the Kennedy Industries truck fleet and transported back to the Kennedy Industries Repair Facility. The pump was then disassembled, blasted, cleaned and thoroughly inspected. The impellers were trimmed and balanced, stiffeners were installed on head and a maintenance friendly coupling guard was installed, at the request of the customer. The pump was rebuilt, painted and returned to the customer in one week. Kennedy Industries Field Service Department reinstalled the pump and motor, provided updated startup reports and service manuals.
